AIRCRAFT ACCIDENT INVESTIGATION REPORT

Japan Air Lines Co., Ltd.
Boeing 747 SR-100, JA8119
Gunma Prefecture, Japan
August 12, 1985

Aircraft Accident Investigation Commission
Ministry of Transport

June 19, 1987

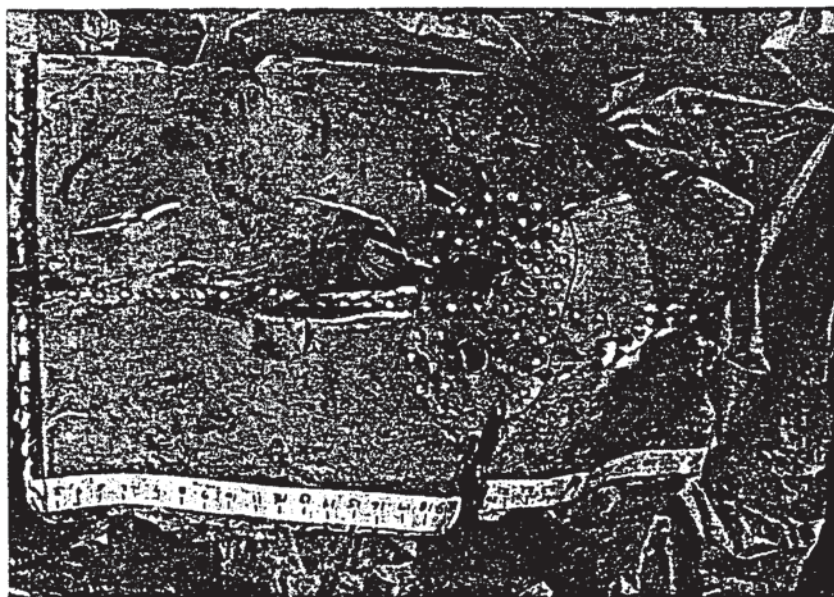
70 Aft pressure bulkhead part 3 (pressurized side)
